CITY COUNCIL ACTION REPORT

SUBJECT: Donation of the Old Stone School Property to the City of Troy
Section 6, Sidwell #88-20-06-101-001

**Old Stone School
Fractional School District
No. 10
Troy, Michigan**

Linda Rivetto
Principles of Preservation Technology
GHPR591
Exterior Assessment Conditions Report
8 March 2004

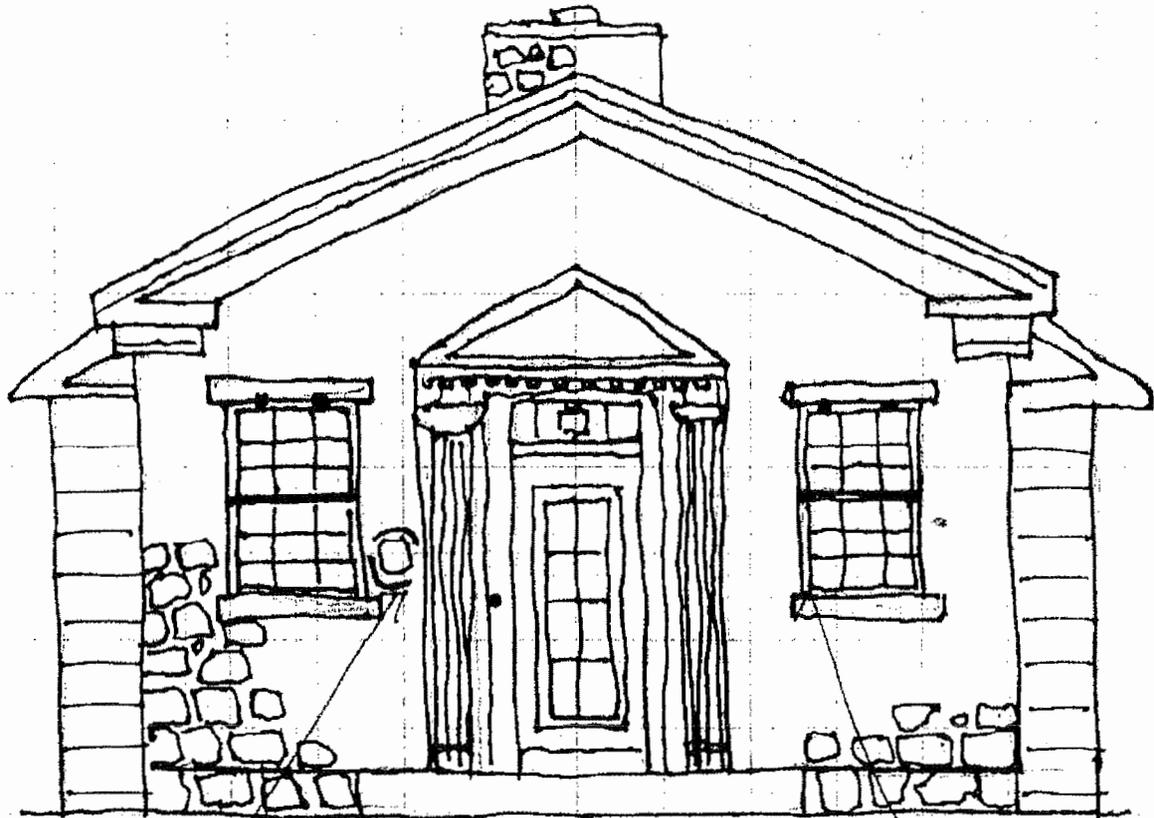
Drawing No. 2

Walls: The stone walls of the schoolhouse are in basically very sound condition. There are mortar cracks on all walls (photos 13, 14). However, there is no indication of a problem caused by these cracks on the interior of the structure. The addition has painted wood siding, which is showing much evidence of weathering and peeling (photo 15).

Windows: All of the windows and storm windows show signs of weathering. The paint is peeling on every window and frame, as well as on the lintels and sills on the stone structure. Also, there has been some warping of the storm windows, especially on the stone building (photos 20-22). There is broken window on the south side of the building (photo 23).

mortar crack

shrubs
obstructing
doorway

storm
window
warped

Walls: The masonry needs some repointing, which would require a thorough research into the type of mortar used originally on the structure. It is important to match the new mortar to the old so that each individual part of the structure responds to stresses in the same way, and so that the new mortar is “sympathetic, supportive, and, if necessary, sacrificial” to the old mortar (Mack 4). An expert should be called in to do the analysis and to determine the correct mortar.

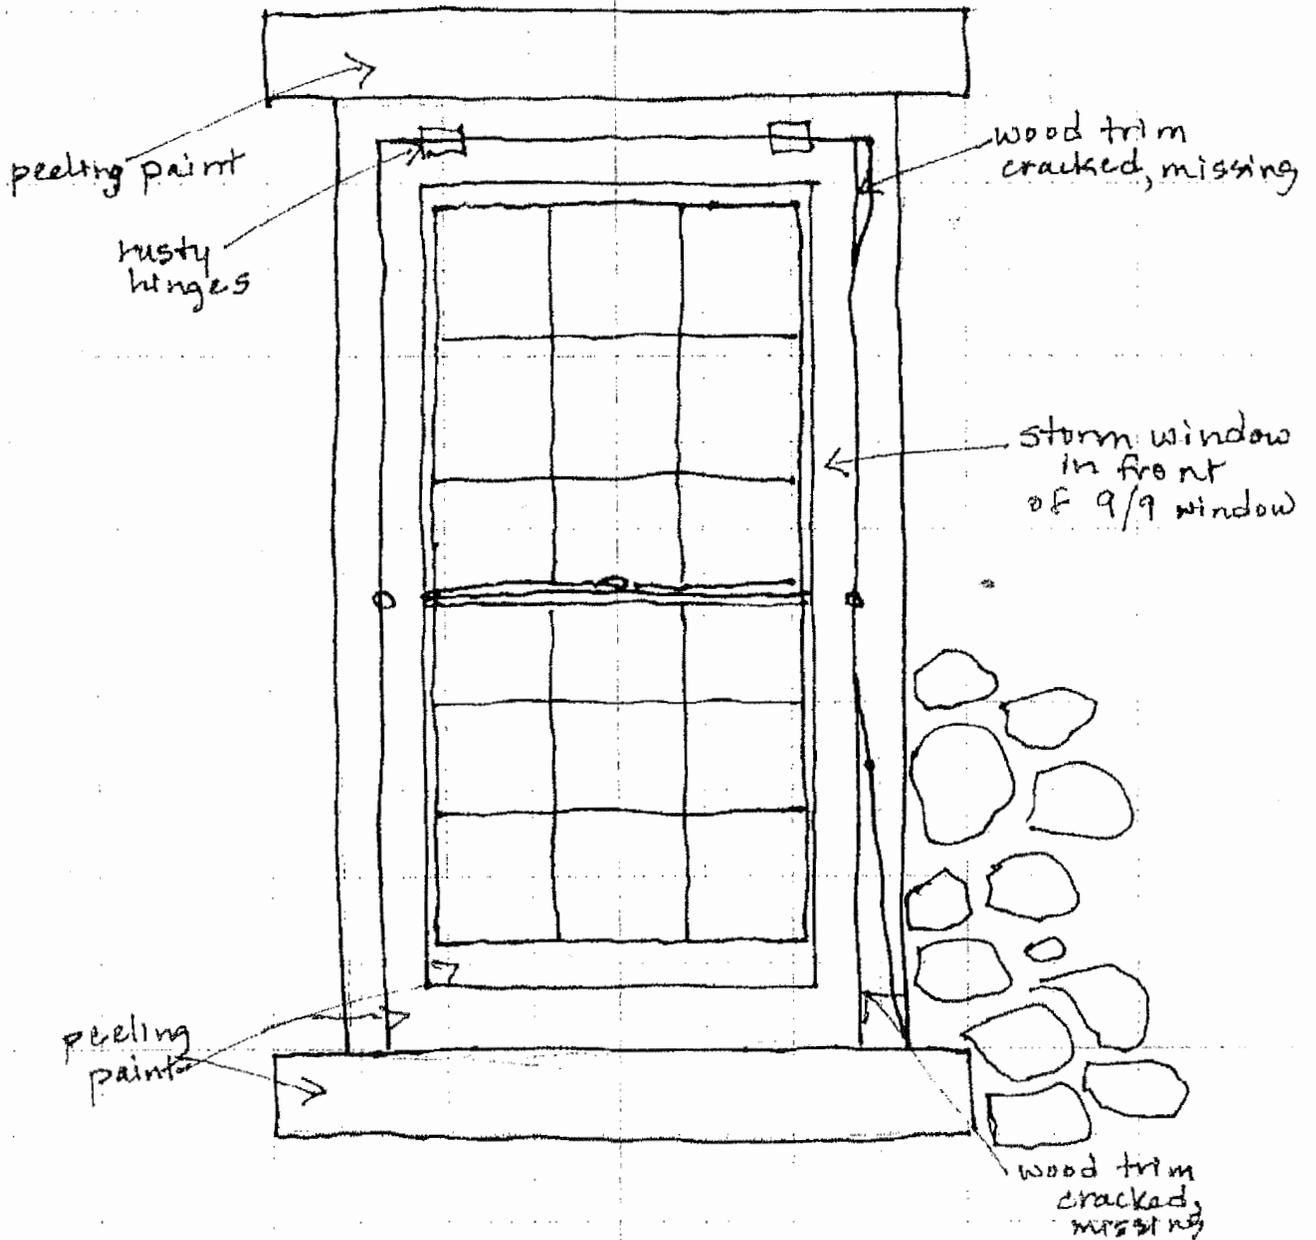
Typical window in stone structure

Windows: As all the windows, with their glass, on the schoolhouse are original, it is desirable to repair them, rather than replace them. The varying conditions of the windows would suggest that all of the repair classes in Preservation Brief No. 9 would probably be used (Myers). Some might only need minor work, others need more stabilizing, and there are a few that have missing woodwork. It would be necessary to use the assistance of a professional who is knowledgeable about historic windows.
