CITY COUNCIL AGENDA ITEM

Subject: Old Stone School Update – Necessity of Selective Demolition

**Old Stone School
Fractional School District
No. 10
Troy, Michigan**

**Linda Rivetto
Principles of Preservation Technology
GHPR591
Exterior Assessment Conditions Report
8 March 2004**

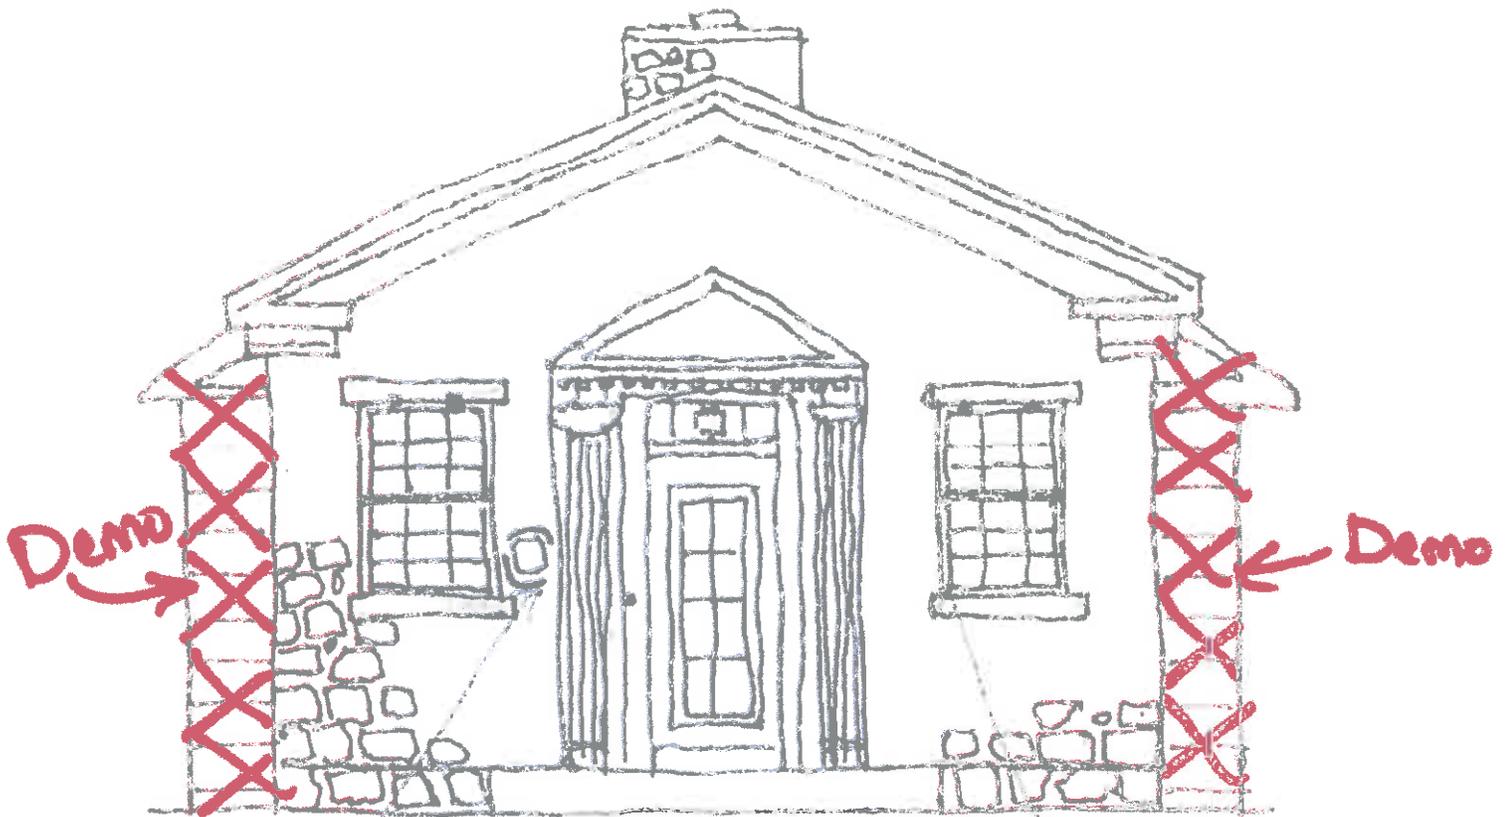
West Elevation

mortar crack

shrubbs
obstructing
driveway

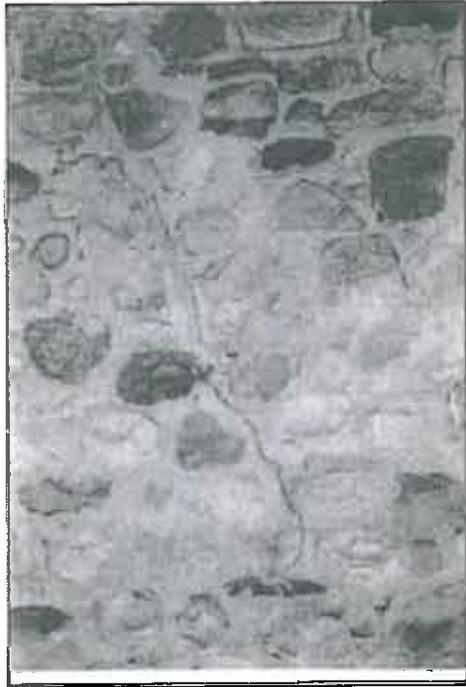
Photo No. 13
Crack in Mortar
Stone School

Walls: The stone walls of the schoolhouse are in basically very sound condition. There are mortar cracks on all walls (photos 13, 14). However, there is no indication of a problem caused by these cracks on the interior of the structure. The addition has painted wood siding, which is showing much evidence of weathering and peeling (photo 15).

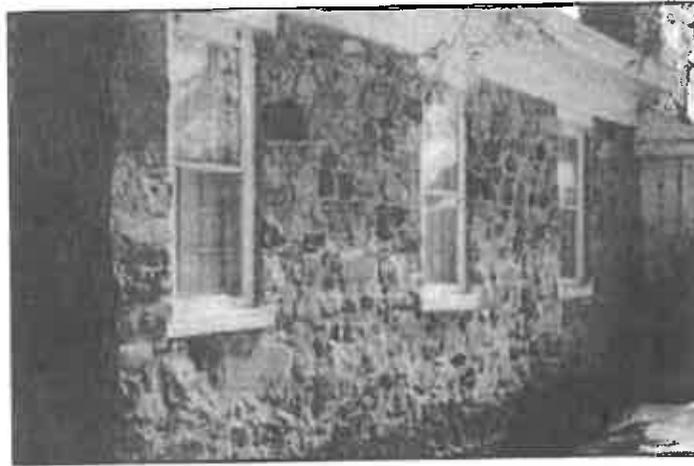
**Photo No. 16
West Side Foundation
Stone School**

Foundation: The stone foundation of the schoolhouse appears dark along both sides of the building (photos 16, 17). It is probable that this is a sign of rising damp. There was no immediate evidence of a problem in this area on the interior of the building. The concrete block foundation of the addition seemed to be in good condition, showing no specific problems (photos 18, 19).

The major cause of deterioration on all parts of this building is water. All wood components show signs of weathering due to rain and snow. The rising damp of the foundation is a result of the roofline draining water very close to the foundation and of the foundation touching the ground. The lack of downspouts and poor condition of the existing gutters adds to the ground drainage problem. The interior ceiling damage is a result of some leakage problem in the roof. The cracked mortar is a result of aging and weathering. The ice dams and icicles, though, are a result of poor or no insulation in the attic areas (photos 24, 25).

Foundation: Because of the possibility of rising damp on the foundation of the stone structure, there is a need to look closely at the water drainage from the building and on the site in general. This location is at Troy’s highest elevation, at 860 feet (Lance 20), so a high water table should not be an issue. However, drainage from the roofline could be a problem, due to the lack of gutters and downspouts.

There could be a need to grade the ground line around the building to facilitate water drainage away from the building (Park 14). Consideration should also be given to historic ways to handle water runoff from the roofline: if gutters and downspouts were not commonly used, and there is not indication of their use on this structure, there may be historic methods used to divert water from building foundations. This would require more research, and perhaps the enlisting of the aid of an expert in the field of moisture control.

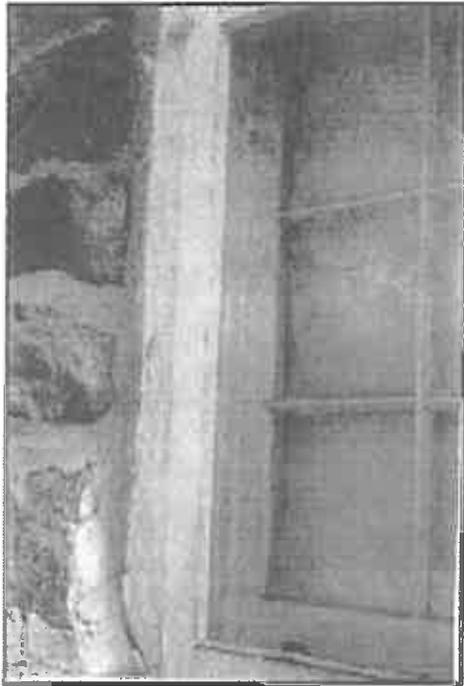
Photo No. 20
Window
Stone School

Windows: All of the windows and storm windows show signs of weathering. The paint is peeling on every window and frame, as well as on the lintels and sills on the stone structure. Also, there has been some warping of the storm windows, especially on the stone building (photos 20-22). There is broken window on the south side of the building (photo 23).

Windows: As all the windows, with their glass, on the schoolhouse are original, it is desirable to repair them, rather than replace them. The varying conditions of the windows would suggest that all of the repair classes in Preservation Brief No. 9 would probably be used (Myers). Some might only need minor work, others need more stabilizing, and there are a few that have missing woodwork. It would be necessary to use the assistance of a professional who is knowledgeable about historic windows.
