CITY COUNCIL AGENDA ITEM

Subject: Old Stone School Update – Necessity of Selective Demolition

**Old Stone School
Fractional School District
No. 10
Troy, Michigan**

**Linda Rivetto
Principles of Preservation Technology
GHPR591
Exterior Assessment Conditions Report
8 March 2004**

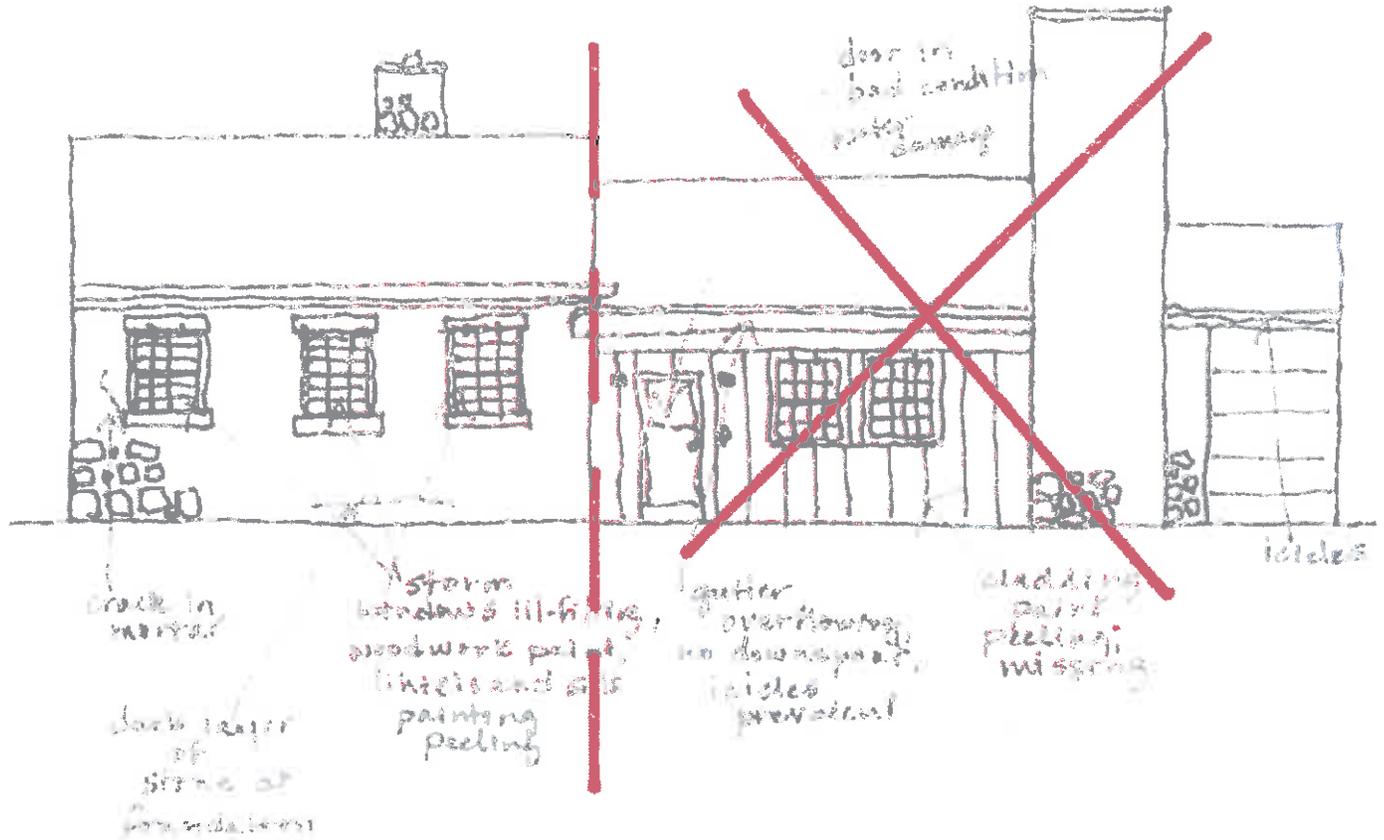
Drawing No. 2

Demolish Non-Historic Addition

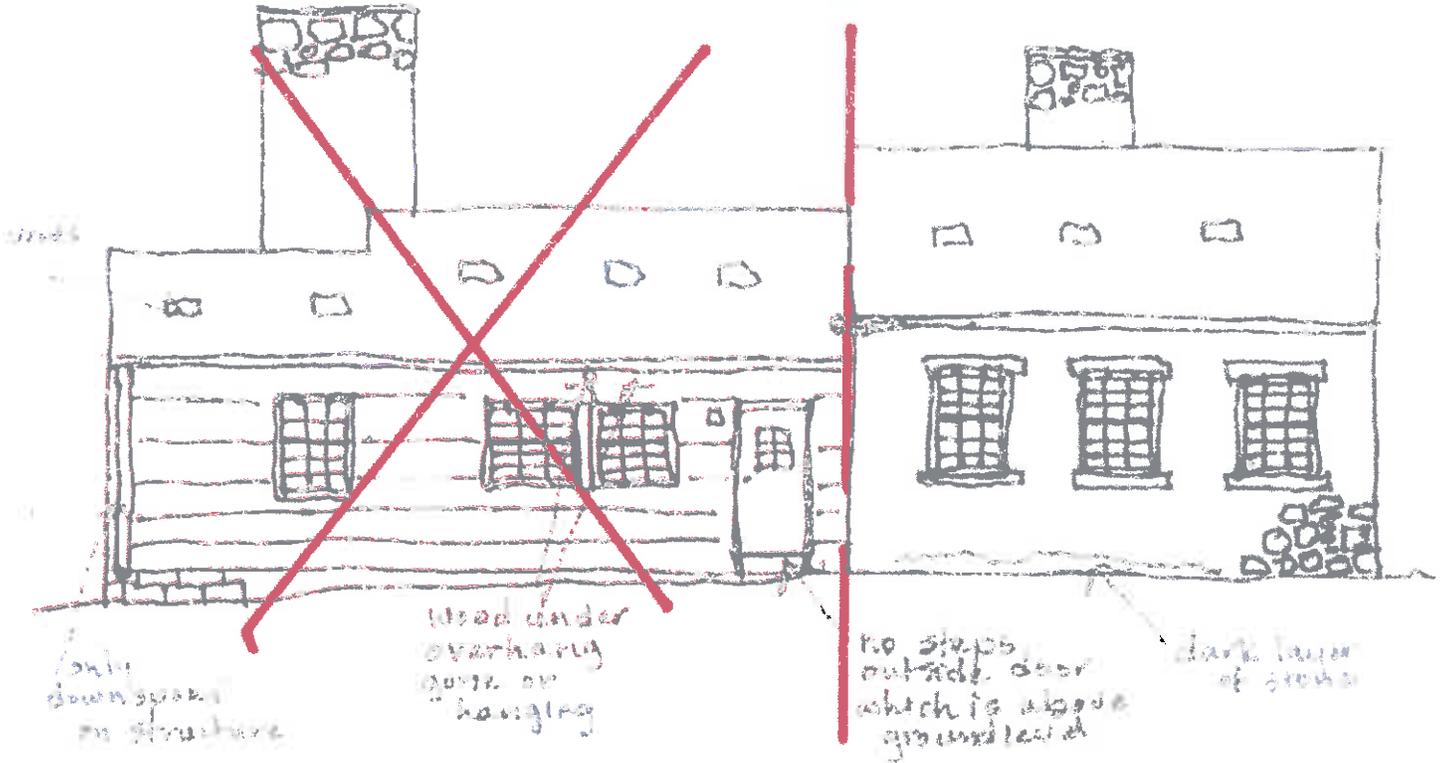
Drawing No. 4

Demolish

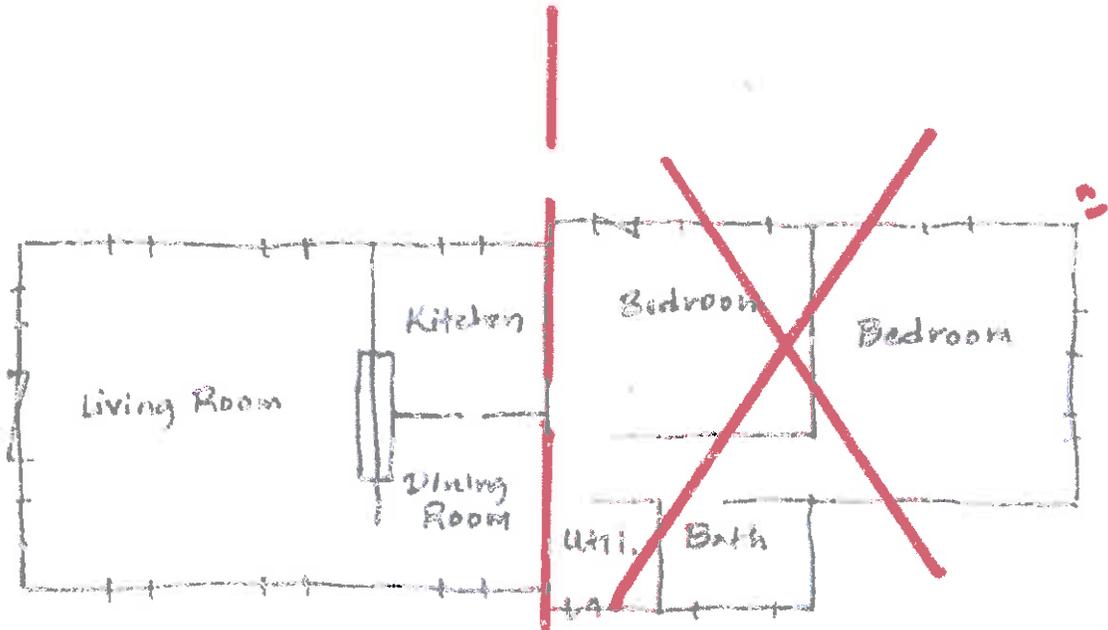
Drawing No. 5

Demolish

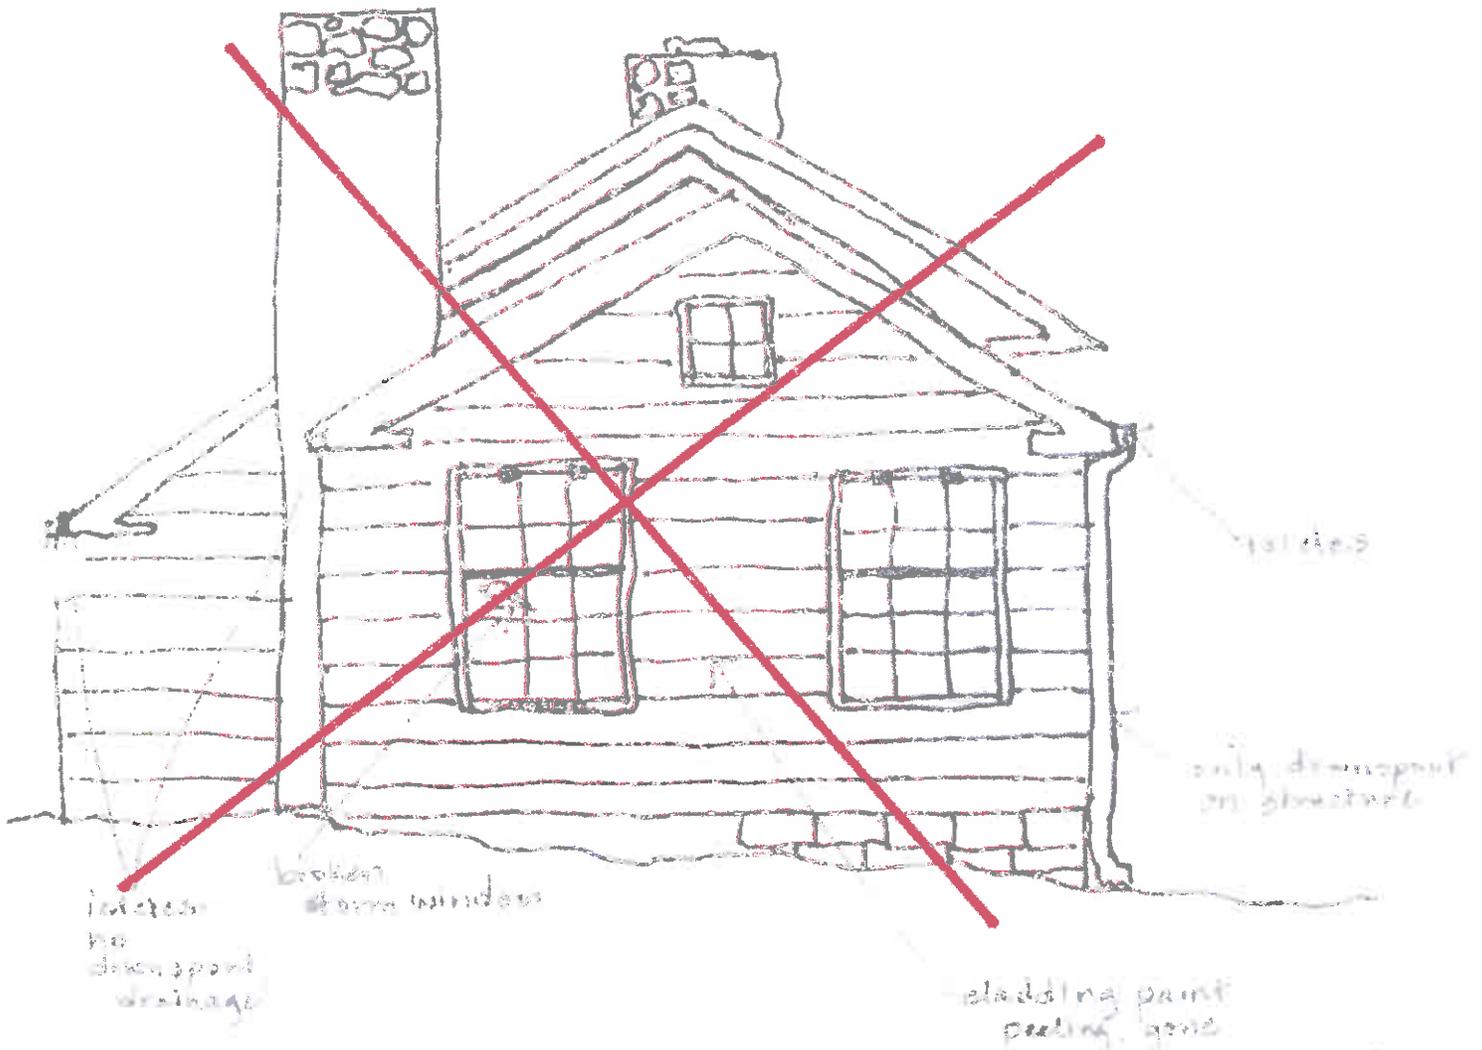
Drawing No. 3

Demo South Addition

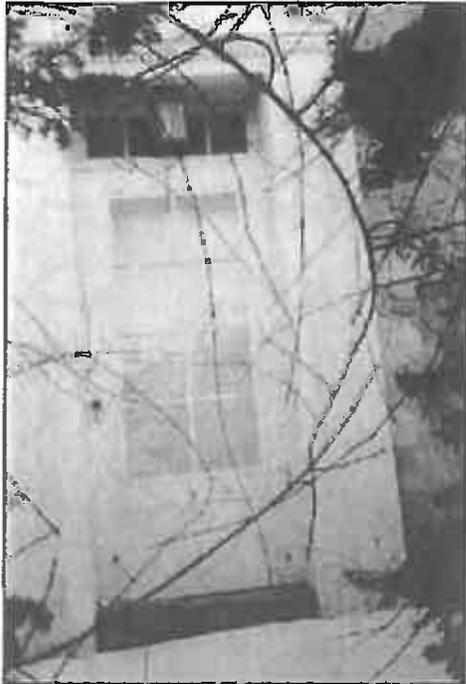
**Photo No. 1
Front Door
Stone School**

Doors: There are three doors on the main building, the main entry door to the schoolhouse, which is no longer actively used, and one door on the east and on the west side of the addition. The east door is not at ground level and has no steps outside of it, so it presumably is no longer used. The schoolhouse door is the original paneled oak door, with a pedimented gable, pilasters, recessed transom lights, and dentil molding (photo 5). There is a

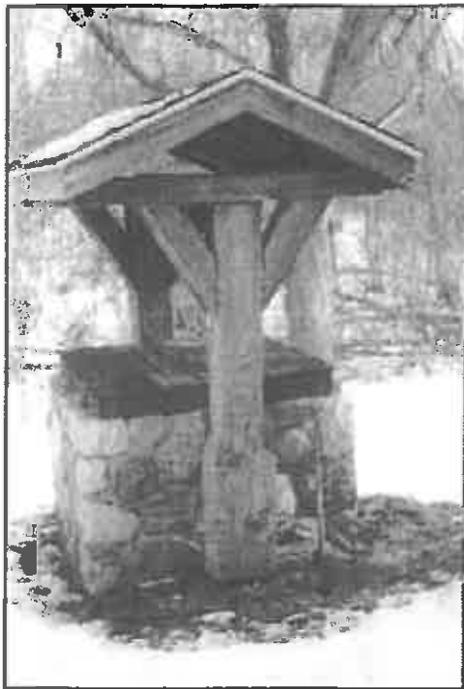
**Photo No.2
Well
Stone School**

There are 3 other structures on the site: a well (photo 2), whose top is currently covered with a wood panel; a stone outhouse with two doors which are original (photo 3); and a part stone/part wood garage – the stone part built in the 1950s with the same stone as the schoolhouse, which was found on the site, and the wood part added on about 1980. The stone section of the garage has been turned into a small apartment, with a kitchen and bathroom.

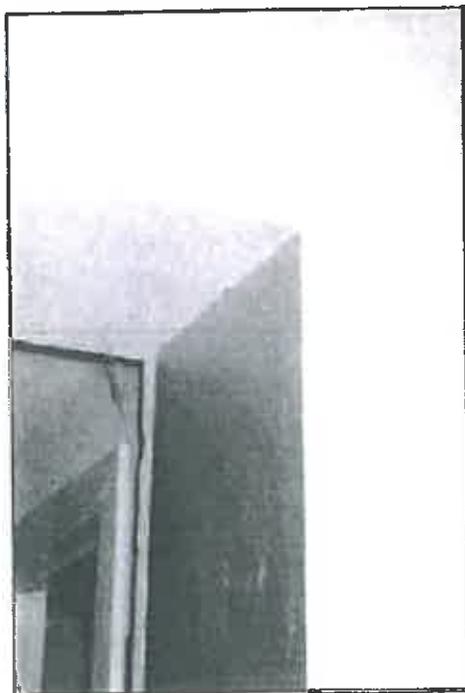
Photo No. 4
Wall Depth
Stone School

Walls: The walls of the stone school portion of the building, as well as of the outhouse and well, are made of mortared local fieldstone, in coursed rubble construction (McAlester 38-9). These walls are 20 inches thick (photo 4). The addition to the schoolhouse is wood-clad, using both horizontal and vertical boards.

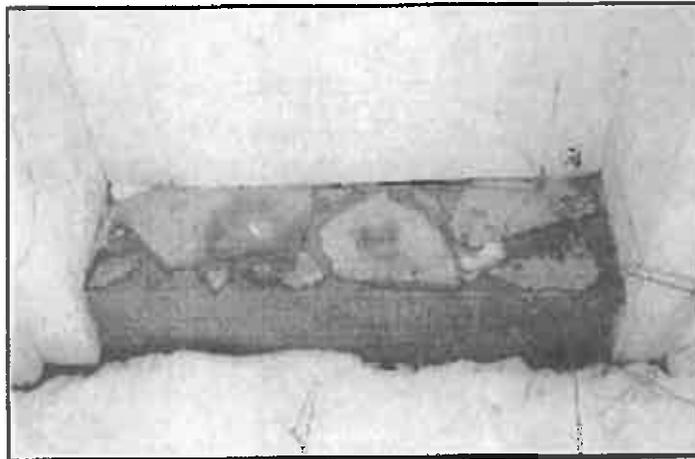
Photo No. 6
Stone Door Sill
Stone School

small front porch in front of the door and a step up to enter the door, onto a stone doorsill (photo 6). The east door is wood panel with 6 windowpanes (photo 7). The west door appears to be an interior luan door (photo 8). There is a small step up to enter this door. All doors have storm doors, wood on the original front door, metal on the two of the addition.

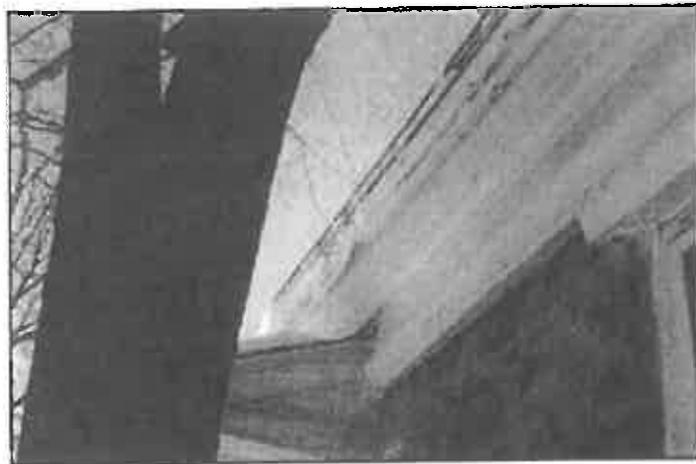
Photo No.9
Dining room Ceiling
Stone School

Roof: The DeGioias replaced the roofs on all the structures in 1979, after they moved in. The exterior of the roof of the schoolhouse building appears to be basically sound, although the roof is about 26 years old. However, a brief interior inspection of the stone building revealed peeling paint on the ceiling of the dining room section of the house, an indication of potential leakages in that area of the roof (photo 9). The cornice line shows weathering with peeling and absent paint (photo 10). In the winter, after a big snowstorm, there are ice dams and icicles at each roofline (photos 11, 12). The gutter on the east side of the house is pulling away from the roofline. And with only one downspout in evidence, despite the existence of a gutter on the west side of the building, water drainage from the roof is definitely questionable.
