COUNCIL REPORT

SUBJECT: Aquatic Habitat Restoration Project Status Report

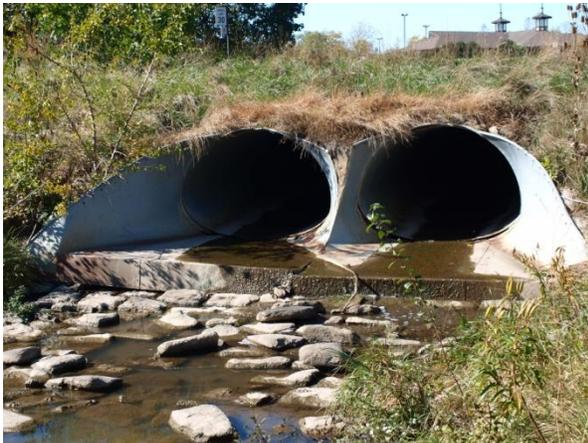
Both sets of twin culverts at Town Center Drive and Civic Center Drive were severely rusted, causing several sink holes. The culverts were in need of replacement for several years.

Town Center Drive Culverts

Approximately \$1 million of the \$2 million dollar project was funded through the Drains Fund; essentially for the replacement of the Town Center and Civic Center Drive road culverts.

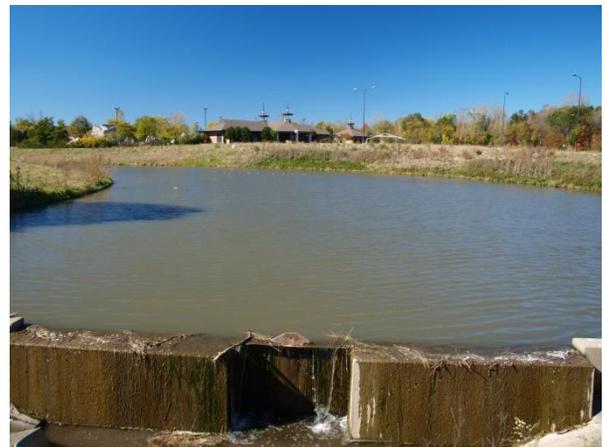
The pond near the Aquatic Center trapped sediment for many years; it had an average depth of less than 2 ft. This accumulation of sediment caused the pond to no longer have the storage capacity needed to mitigate flooding during severe storm events. In addition, the overflow weir that regulated storm flow created a barrier to fish and aquatic organisms, as did the road culverts that were higher than the stream bed.

Aquatic Center Pond Weir Wall

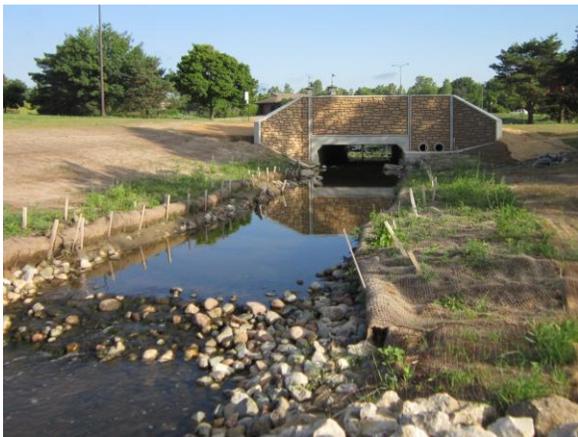
Town Center Drive Box Culvert

Construction has been completed and cleanup of the staging area south of Town Center Drive is near complete, but work continues on restoration.

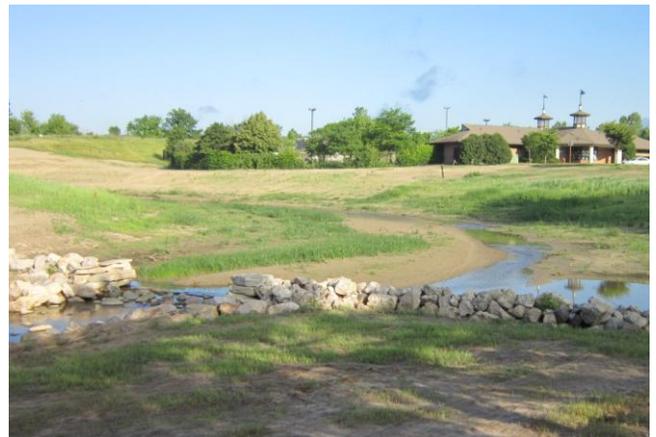
Construction started in July, 2013. Heavy rains plagued the project last summer and fall, causing much of the work to be deferred to 2014. Spring and summer rains this year have been problematic as well since they have tended to be heavy downpours. This has caused significant problems with the restoration. Seeding was done several times only to have it washed away. Steam bank erosion has also taken place despite the stabilization work.

Stream and Floodplain

A site meeting is scheduled for Wednesday, July 23 to fully inspect the project and prepare a punch list for restoration. Much of the seeding and hydro mulching that was installed will need attention due to heavy rain washouts that have occurred. Valleys formed by erosion will need to be hand raked, re-seeded and mulched. Watering will be needed now that dryer weather is approaching to ensure that growth of the desired species will occur and that the planted native plant species will survive. Given the time of year, this work will likely continue on into fall when more temperate weather will help with the restoration.
